# Technical Information

## Big Room Air Conditioner

**CU-B14DBE5 CU-B18DBE5**  
**CU-B24DBE5 CU-B28DBE5**  
**CU-B28DBE8 CU-B34DBE5**  
**CU-B34DBE8 CU-B43DBE8**  
**CU-B50DBE8**

**Subject : Big Rac Communication Error (F27-01)**

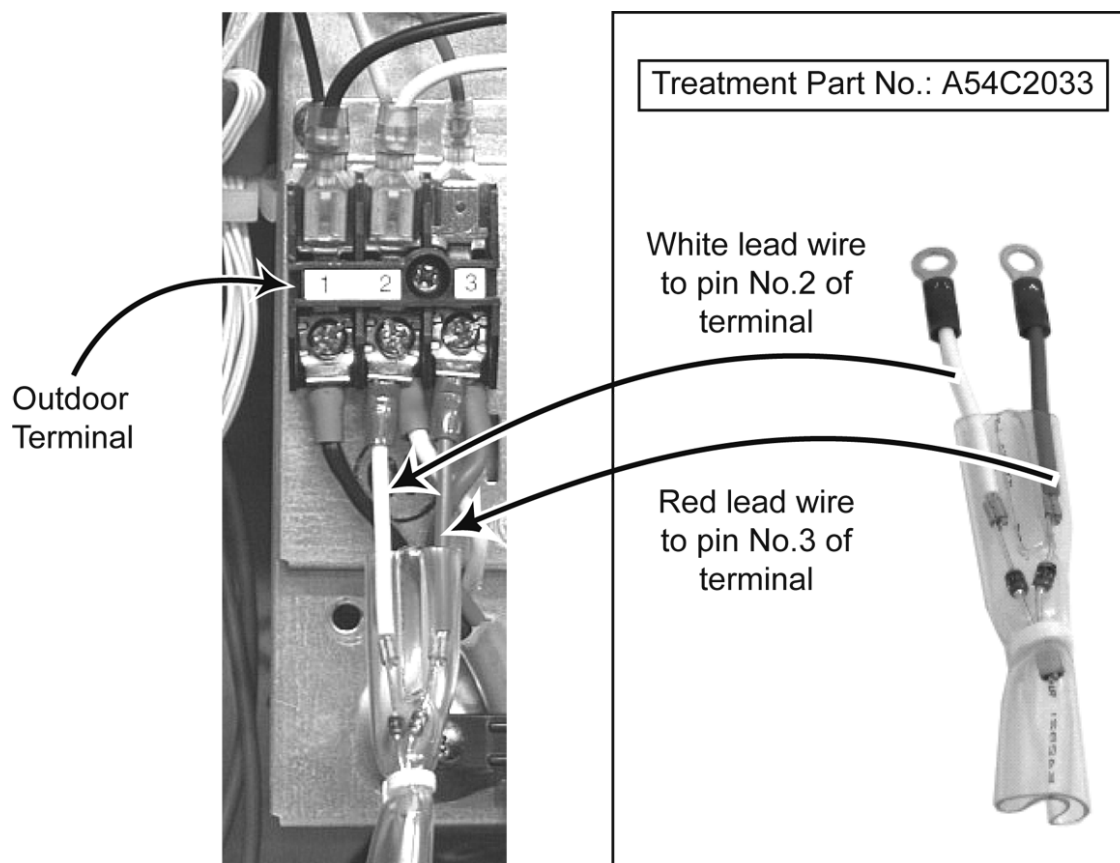
The damage to the outdoor PCB's communication line (F27-01) is due to the transient voltage passing through the communication line as a result of which a Life line (pole) being turned ON first and a Neutral line (pole) being turned ON later.

- Connect the market treatment part (Code No.:A54C2033) to the outdoor unit communication terminal (between No.2-pin and No.3-pin).
- The treatment part should be tightened together with the indoor-outdoor communication cable.
- Connect the treatment part's white lead wire to No.2-pin of the terminal, and the treatment's part red lead wire to No.3-pin of the terminal.
